# LINE OF DUTY DEATH REPORT

REPORT F2021-11 • May 2025

## ***Firefighter Dies and Lieutenant Seriously Injured at a Multi-Family Residential Structure Fire – Connecticut***

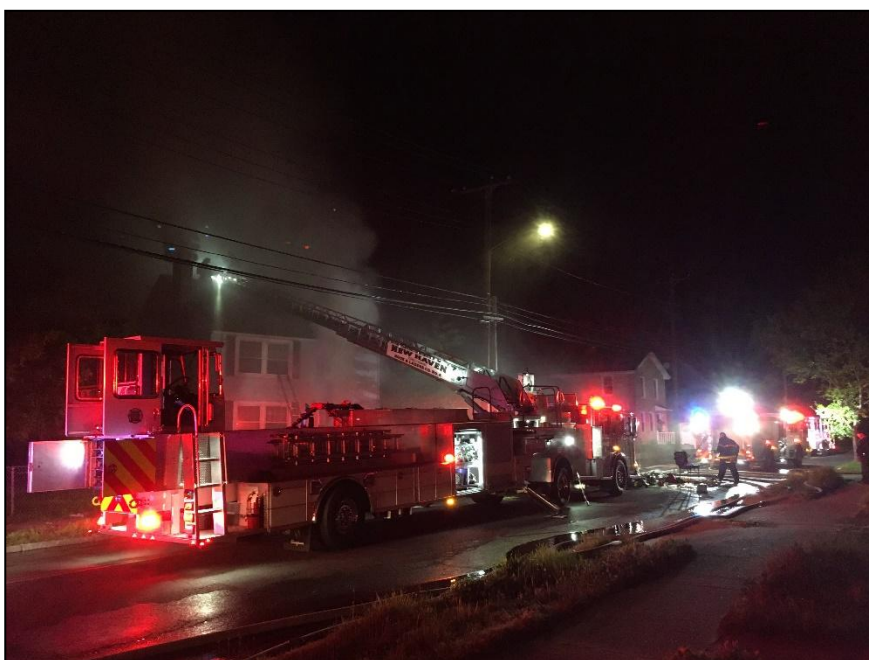
**Photo 1: Truck 4 conducting roof ventilation at Box 1501.**  
(Courtesy of the fire department)

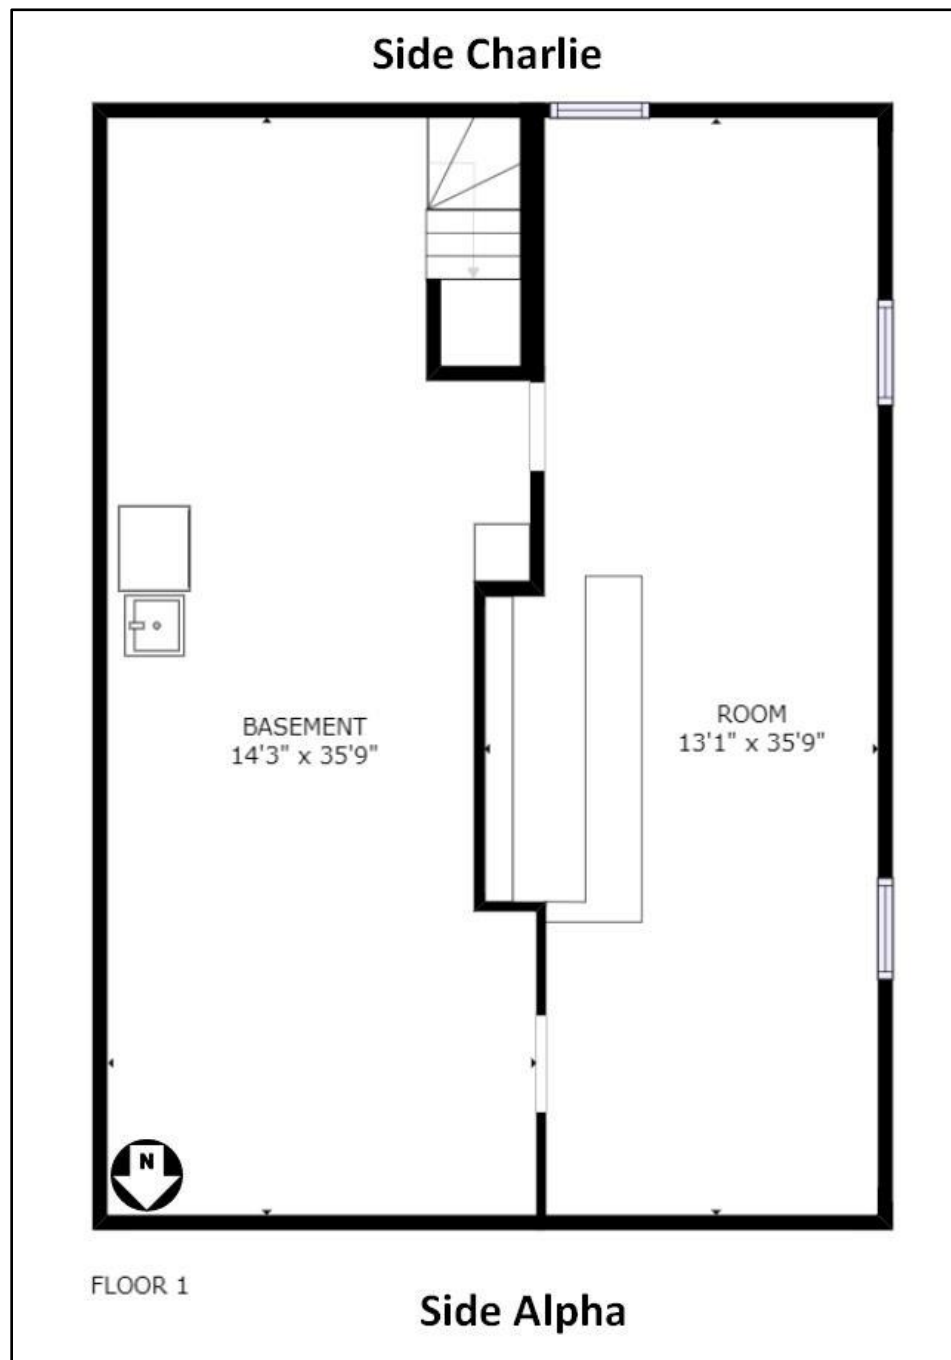
**Diagram 1. Floor plan of the basement. Note: Identified as Floor 1 in the diagram provided by Envision Forensics.**

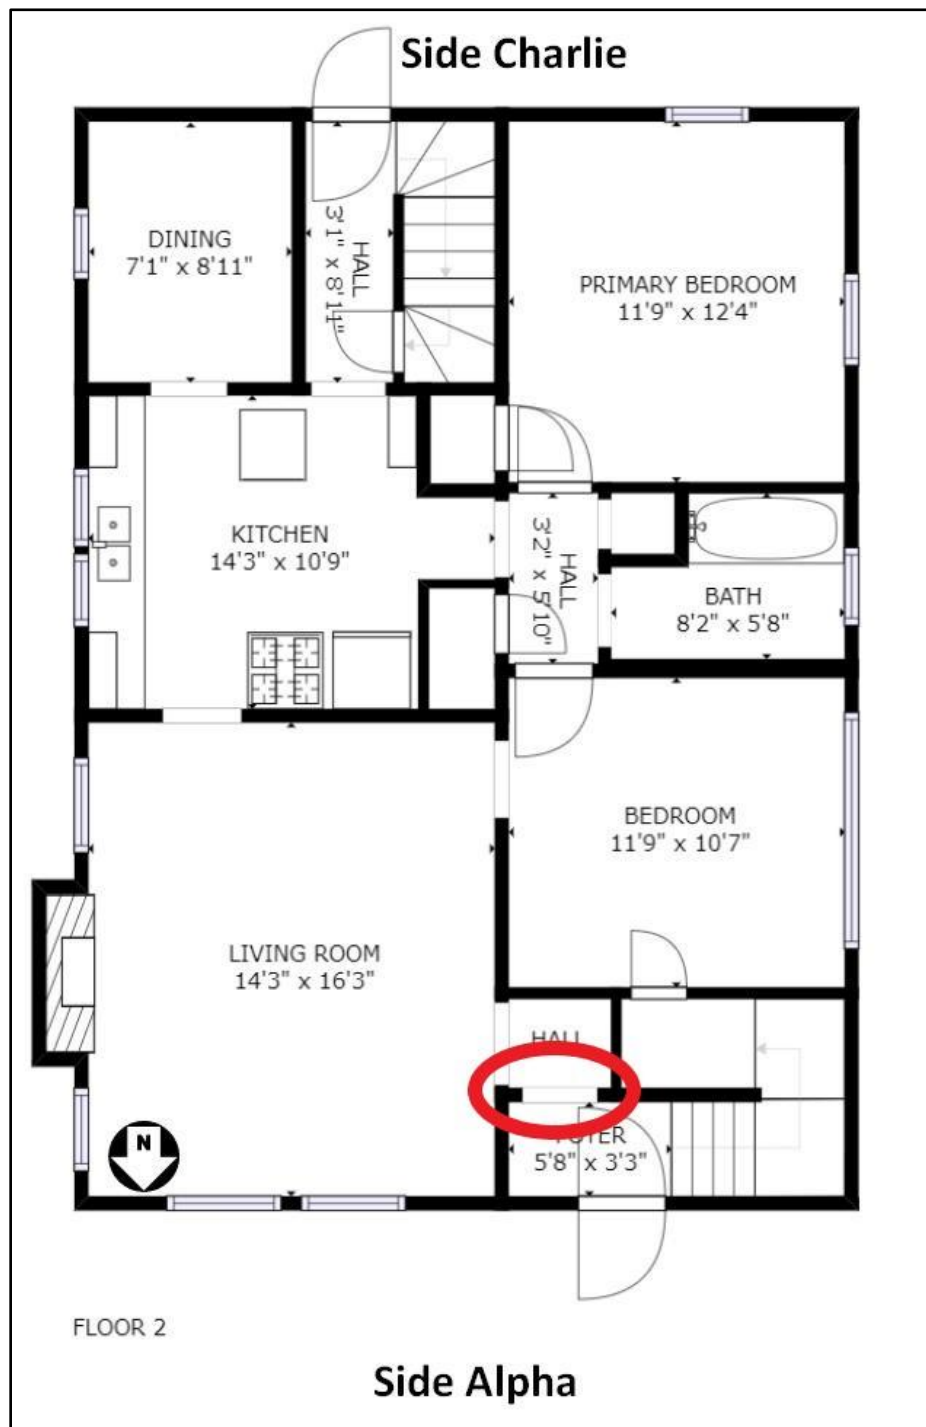
**Diagram 2. The floor plan of the 1st floor apartment. The red circle indicates the doorway that was blocked with a bookcase for security reasons. The only access into this apartment was through Side Charlie. Note: Diagram provided by *Envision Forensics* labeled this Floor 2.**

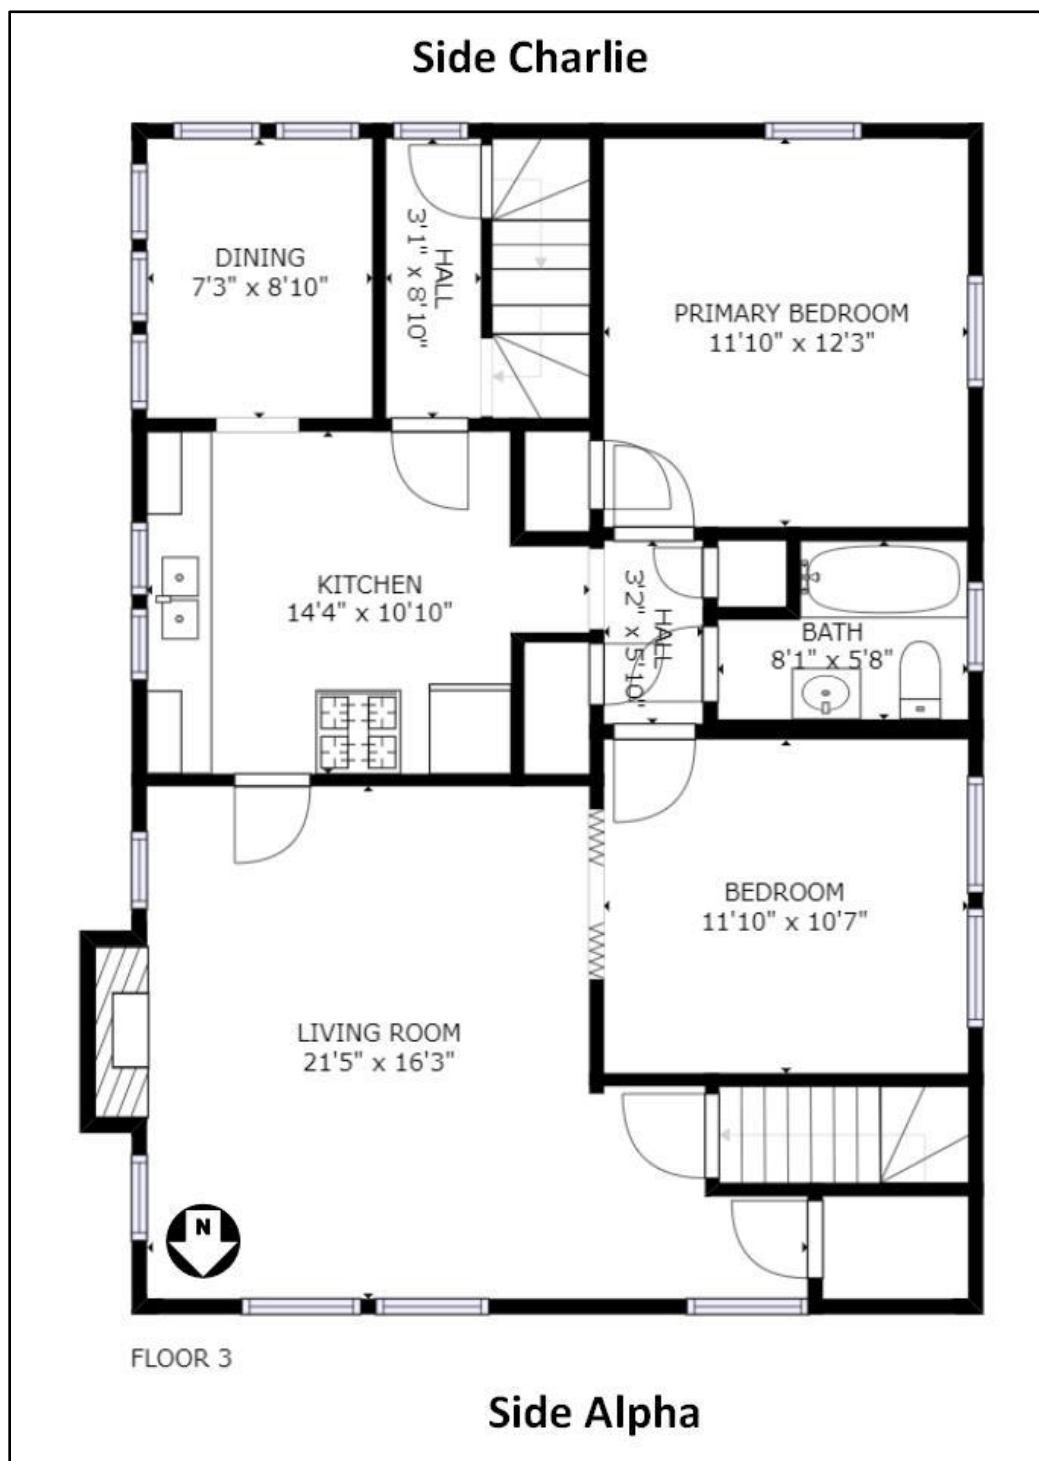
**Diagram 3. The floor plan of the 2<sup>nd</sup> floor apartment. Note: Diagram provided by *Envision Forensics* labeled this Floor 3.**

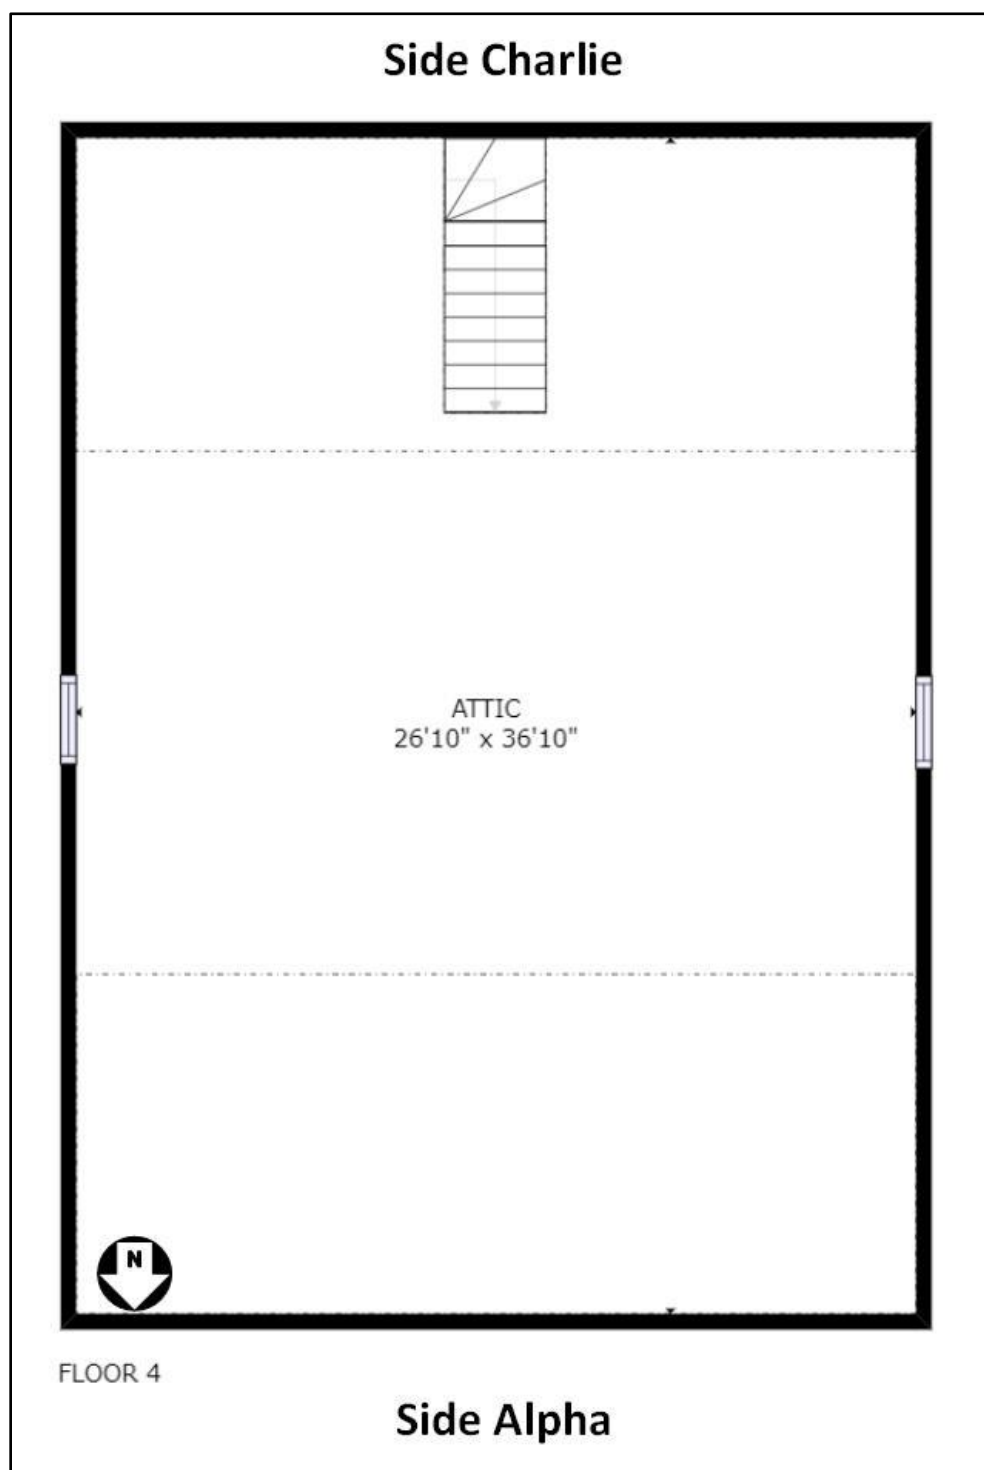
**Diagram 4. The floor plan of the attic containing storage. Note: Diagram provided by *Courtesy of Envision Forensics* labeled this Floor 4.**

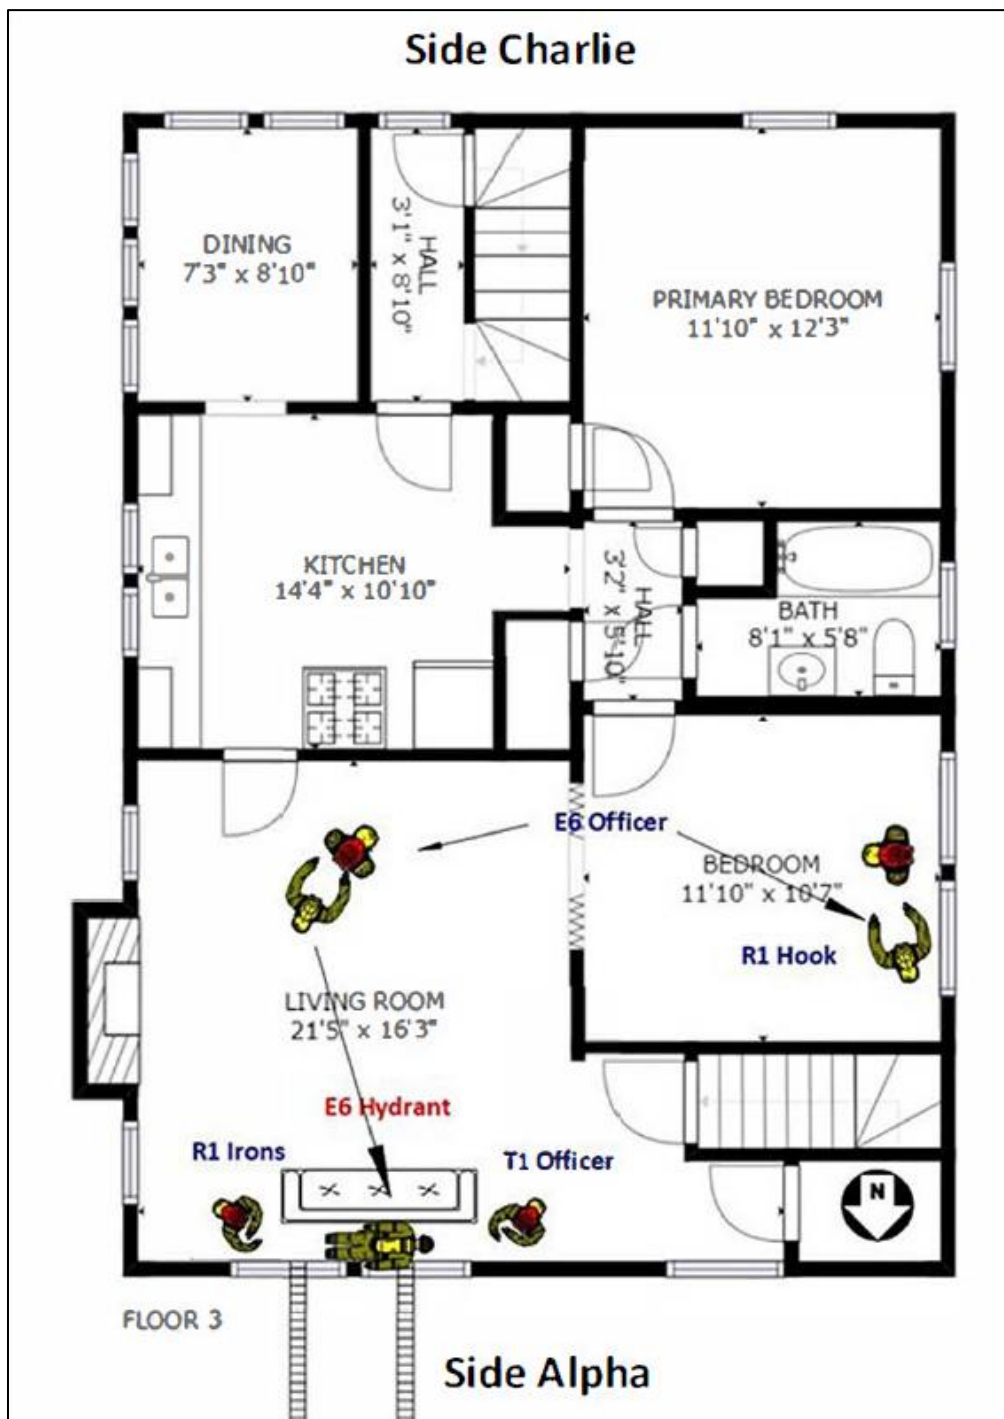
At approximately 01:21 hours, Rescue 1 Irons made his way into the living room. He found Engine 6 Hydrant lying prone with his facepiece on but out of air. Rescue 1 Irons tried to move Engine 6 Hydrant from between the couch and a radiator underneath the front window. Truck 1 Officer came into the front room (living room) and heard a PASS alarm sounding. He assisted Rescue 1 Irons and Truck 1 Officer with dragging Engine 6 Hydrant to the window. The firefighters tried but were unable to get Engine 6 Hydrant out through the front windows. Rescue 1 Irons and Truck 1 Officer went outside due to being low on air. Truck 1 Officer met Engine 11 and described Engine 6 Hydrant’s exact location in the living room. Engine 11 entered the building, went up the front stairs, and found Engine 6 Hydrant behind a couch near the windows on Side Alpha. Engine 11 brought Engine 6 Hydrant down the front stairs to the outside at 01:33 hours. Both Engine 6 Lieutenant and Engine 6 Hydrant were transported to a local university trauma center. Engine 6 Hydrant was declared deceased in the emergency room at 02:12 hours. Engine 6 Lieutenant was later transferred to a trauma hospital with a hyperbaric chamber for treatment and recovery. IC advised Fire Dispatch that the fire was under control at Box 1501 at 03:23 hours.

**Diagram 5. On the 2<sup>nd</sup> floor, the location of Engine 6 Hydrant and the Engine 6 Lieutenant (labeled as officer) after the Mayday occurred. The arrows indicate the paths of Engine 6 Officer took to the bedroom and Engine 6 Hydrant to the front window. (Prepared by NIOSH)**

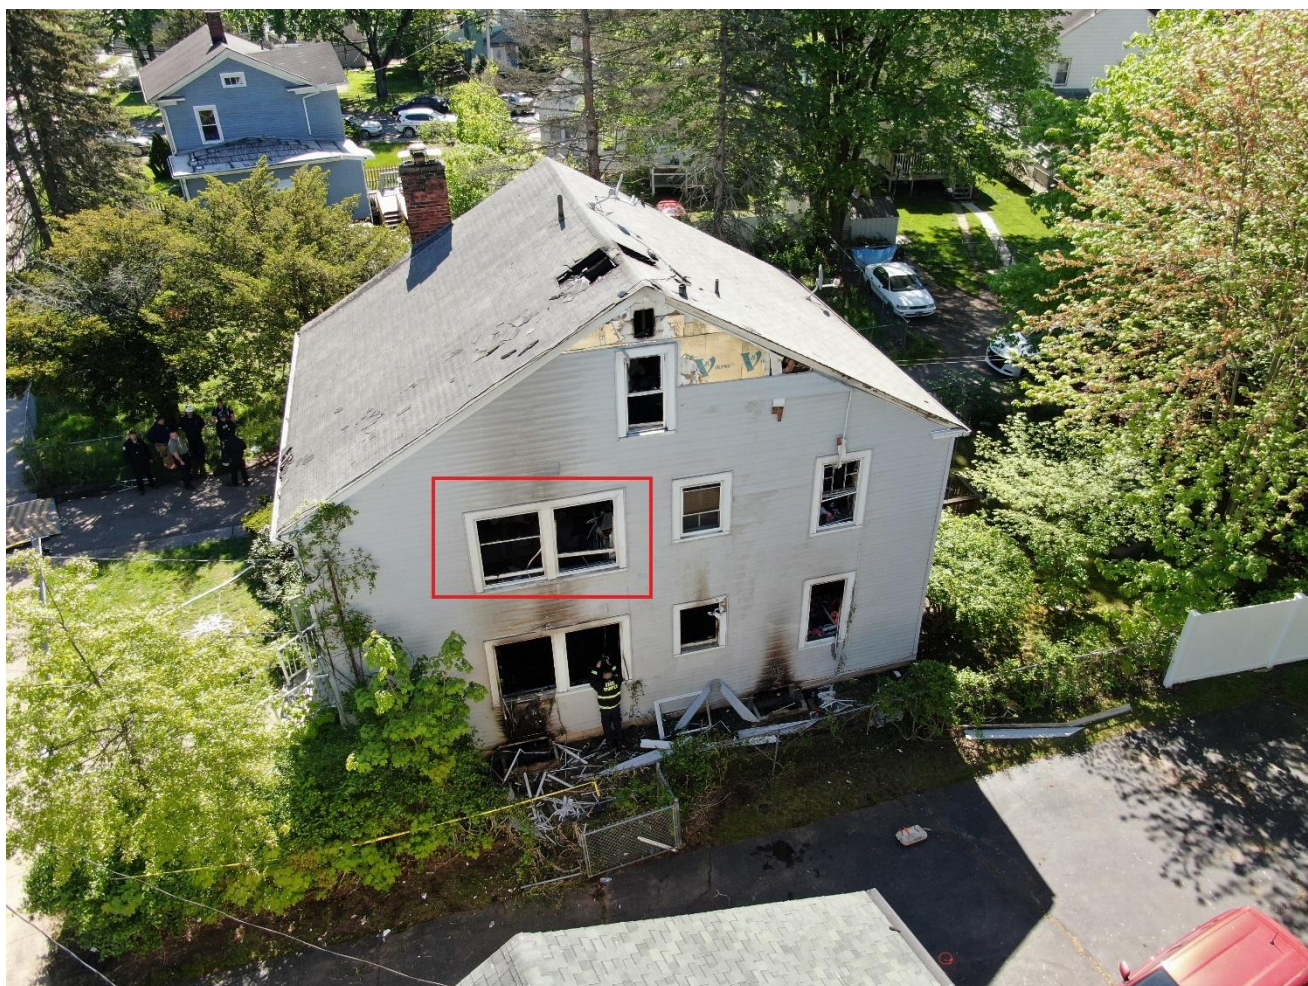
Engine 6 Lieutenant was located by Rescue 1 Hook who found Engine 6 Lieutenant in the living room near the entrance to the kitchen. Engine 6 Lieutenant had his facepiece and gloves off and was standing when the firefighter found him. He said, “Help me,” and then fell into the firefighter. Engine 6 Lieutenant’s helmet was found in the Side Alpha/Side Bravo corner near the firefighter from Engine 6. Rescue 1 Hook tried to get Engine 6 Lieutenant to the stairs but got him into a bedroom (Side Delta/Side Alpha corner) at approximately 01:23–01:24 hours. Rescue 1 Hook knocked the glass out of a window. Firefighters from Engine 4 and Engine 9 got ground ladders to the windows. Rescue 1 Hook tried to get Engine 6 Lieutenant out the window, but he was too heavy. Low on air, Rescue 1 Hook had to leave, using the window and ground ladder set up by Engine 5 and Engine 9. Once he was on the ground, he advised Car 31 where Engine 6 Lieutenant was located. Firefighters from Engine 4 and Engine 9 got Engine 6 Lieutenant out of the house at 01:33 hours.

**Photo 2. The 2nd floor window on Side Delta where Engine 6 Lieutenant was rescued from by Engine 4 and Engine 9**  
*(Courtesy of the fire department)*
